Level 1, Platinum Reserve Analysis

# Bear Mountain Townhouse HOA 1395 Bear Mountain Dr. Boulder, CO. 80305

Final Version
Report Period – 01/01/20 – 12/31/20
Client Reference Number – 07771-19
Property Type – Townhomes
Fiscal Year End – December 31st
Number of Units – 10
Date of Property Observation – March 27, 2019
Property Observation Conducted by- Justin Huggins
Project Manager – Justin Huggins
Main Contact Person – Cindy Smith, Community Association Manager

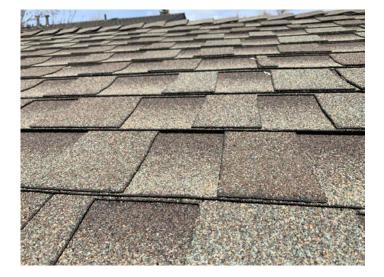
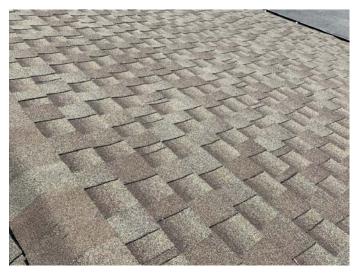
# Comp #: 105 Comp Shingle Roof - Replace

- The roofs appeared to be in fair condition at the time of the site observation.

- Remaining life has been extended to 10 years based on the reports a roofer will maintain as needed until replacement.

Location:	Unit Bldgs and Garage Roofs		
Quantity:	Approx. 230 Squares		
Life Expectancy:	20	Remaining Life:	10
Best Cost:	\$97,	750	
\$425/square; Estimate to remove and replace

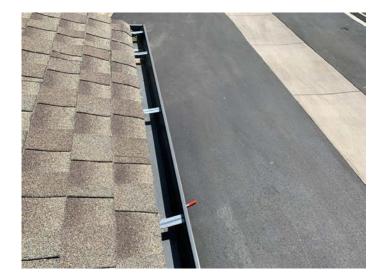
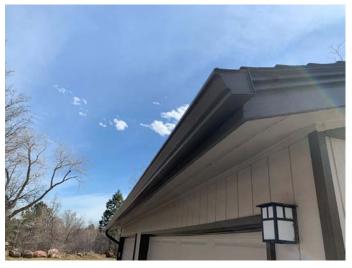
# Comp #: 120 Gutters/Downspouts - Replace

- There were some dents and other signs of damage noted, however, the overall condition of the gutters and downspouts was fair.

- It is typical to replace gutters and downspouts at the same time as roofing materials.

Location:	Unit Bldgs and Garage Roofs		
Quantity:	Approx. 1,560 LF		
Life Expectancy:	20 Remaining Life: 10		
Best Cost:	\$10,925		
\$7.00/LF; Estimate to replace			
Worst Cost:	\$12,500		
\$8.00/LF: Higher estimate for larger lines

- We recommend cleaning debris out of lines at least once a year to prevent clogging and moisture retention that can lead to advanced deterioration.

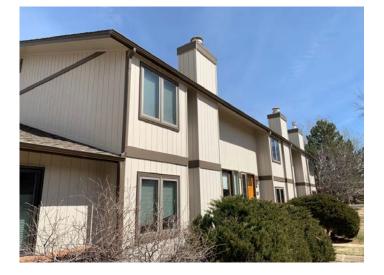
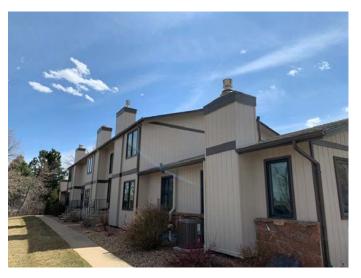
# Comp #: 204 Building Ext Surfaces - Repaint

- The paint on the exteriors of the unit buildings and garages was in good condition at the time of the site observation.

- In this climate, it is recommended that exterior surfaces are painted every 5 - 6 years.

- The remaining life is based on the observed conditions.

Location:	Unit Bldg and Garage Exteriors		
Quantity:	(10) Units		
Life Expectancy:	7 Remaining Life: 5		
Best Cost:	\$24,000		
\$2,400/unit; Estimate to repaint			
<i>Worst Cost: <b>\$30,000</b></i> \$3,000/unit; Hhigher estimate for more labor			
Source of Information: Cost Database

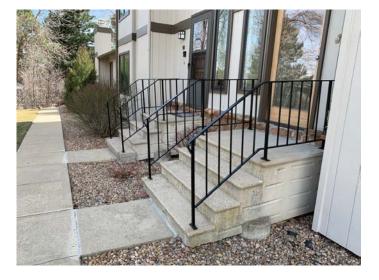
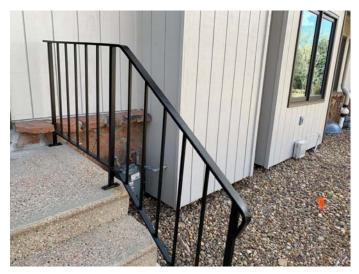
# Comp #: 207 Iron Handrails - Repaint

- Funding is included with Component 204.
- Separate Reserve funding is not necessary at this time.

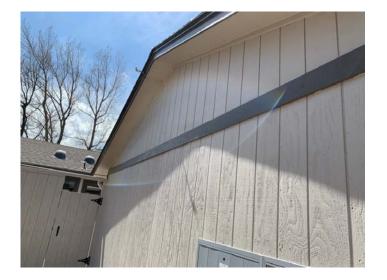
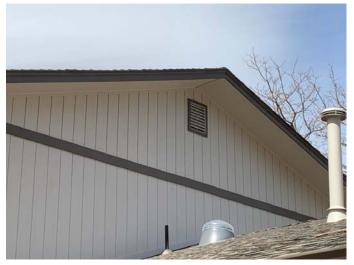
## Comp #: 303 Wood Siding - Major Repairs

- The siding appeared to be in good to fair conditions with minimal signs of damage noted.

- In order to keep up the appearance of the community and to ensure a maximum life of siding, we have established a Reserve allowance for major repairs and some replacement every other painting cycle.

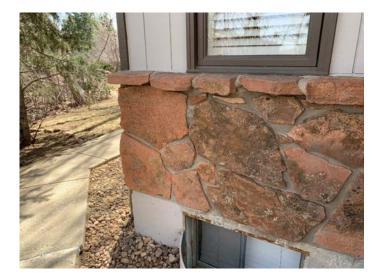
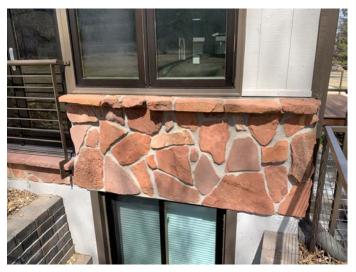
# Comp #: 306 Flagstone/Moss Rock - Replace

- Typically, this material has an extended life expectancy and complete replacement is unlikely.

- There are times where minor repairs may become necessary, but this is unpredictable when and how much would occur.

- Repairs should be handled as a maintenance issue on an as needed basis.
- Reserve funding is not required for this component at this time.
- If it later turns out that frequent repairs are necessary, then funding could be added in future Reserve Study updates.

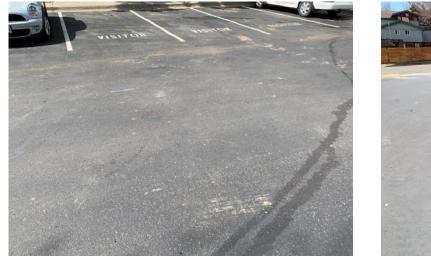
# Comp #: 401 Asphalt - Overlay

- The asphalt was in very good condition at the time of the site observation.

Location:	Common drive
Quantity:	Approx. 11,950 GSF
Best Cost:	<ul><li>24 Remaining Life: 20</li><li>\$23,900</li><li>o rotomill and 2" overlay</li></ul>
<i>Worst Cost:</i> \$2.25/GSF; Highe	<b>\$26,900</b> er estimate for more repairs

- Maintenance includes crack fill and repairing small potholes annually as an operating expense.

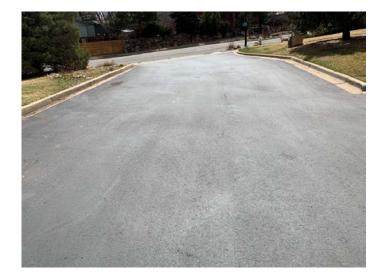
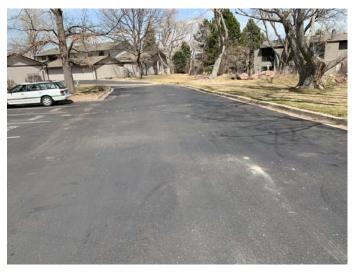
# Comp #: 402 Asphalt - Seal Coat/crack fill

- In this environment, expect to seal asphalt every 2 - 4 years, depending on traffic levels and effects from weather.

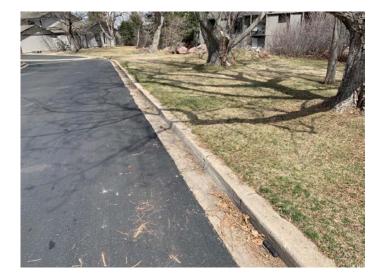
# Comp #: 403 Concrete - Partial Replace

- At the time of the inspections, there were a many areas showing signs of significant cracking.

Location:	Throughout Property
Quantity:	Approx. 1,840 GSF
Life Expectancy:	8 Remaining Life: 5
Best Cost:	\$4,450
Estimate to repair	20% of area every 8 years
<i>Worst Cost:</i> Higher estimate fo	<b>\$5,200</b> r more repairs

- Since it is unlikely that all surfaces will need to be replaced at the same time, we suggest establishing a Reserve fund to repair 20% of area (370 GSF) every 8 years.

- Coordinate future repairs with other concrete repairs and asphalt work to obtain the best cost.

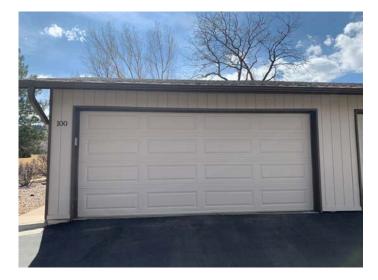
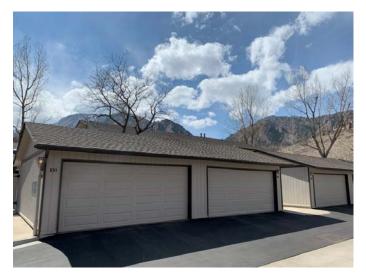
# Comp #: 502 Garage Doors - Replace

- The garage doors appeared to be in fair condition.

- It was requested the remaining useful life be extended to 12 years. We believe that is too long based on the observed conditions. We did extend the useful life from 4 years to 7 years.

Location:	Garage units
Quantity:	(10) 16x7 garage doors
Life Expectancy:	22 Remaining Life: 7
Best Cost:	\$12,000
\$1,200/door; Estin	nate to replace doors
<i>Worst Cost:</i> \$1,500/door; High	<b>\$15,000</b> er estimate for better quality
Source of Informa	tion: Cost Database

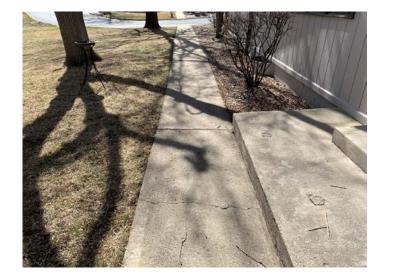
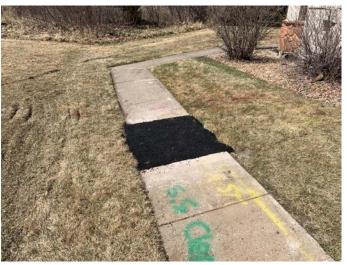
## Comp #: 601 Concrete Sidewalks/Decks - Repair

- At the time of the site observation, there were some areas of concrete sidewalks with trip hazards and signs of deterioration noted.

Location:	Thre	bughout community
Quantity:	Арр	rox. 3,440 GSF
Life Expectancy:	4	Remaining Life: 3
Best Cost:	\$7,7	00
Allowance to repair	ir 20%	% of area every 4 years

- While it is unlikely that all concrete surfaces will fail and need to be replaced at the same time, frequent repairs and replacement to a percentage of the area (20% or 700 GSF), should be anticipated every 4 years.

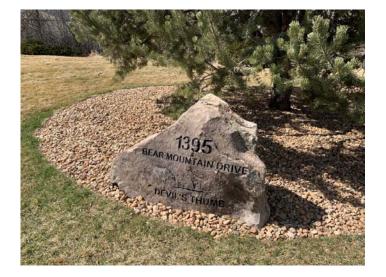
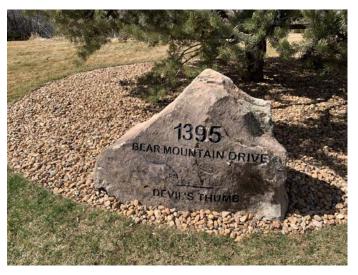
# Comp #: 801 Monument - Rebuild

- This stone should have an indefinite life expectancy.
- Repaint lettering as needed with operating funds.
- Separate Reserve funding is not required for this component.

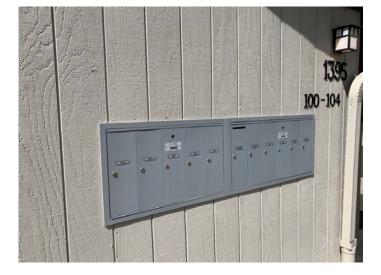
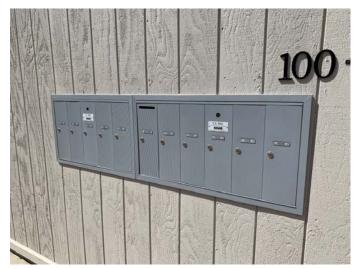
### Comp #: 803 Mailboxes - Replace

Boxes are generally in fair condition with no unusual conditions observed. There were no signs of any broken boxes observed. The average life expectancy for this type of box ranges between 15 - 20 years to maintain appearance and function. Remaining life based on observed condition.

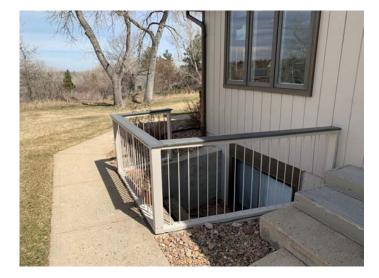
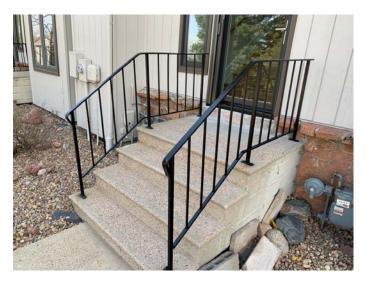
# Comp #: 1002 Handrails - Replace

The handrails on the front porches are showing signs of deterioration at the bottom with some rusting and faded paint noted.

- The rails around the window wells are a different material and appeared to be in better condition.
- There were no major rusting or structural problems noted at the time of inspection.
- We suggest treating any small repairs as a maintenance issue.
- Due to the small area, Reserve funding is not required for replacement of this component.

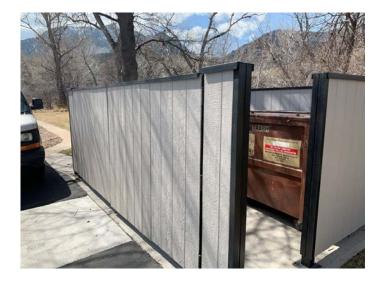
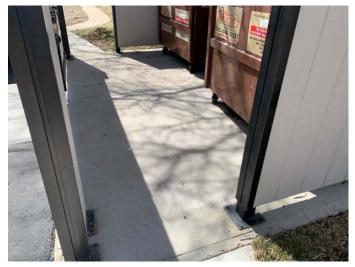
# Comp #: 1010 Trash Enclosures - Major Repairs

- Painting is included with separate components.

- Expect frequent repairs and replacement to the gates and possibly the siding due to the exposure to elements and probability of abuse from rubbish companies.

- In our experience, we typically see the need for repairs every 5 - 10 years, depending on the level of abuse.

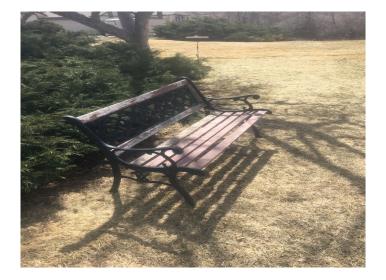
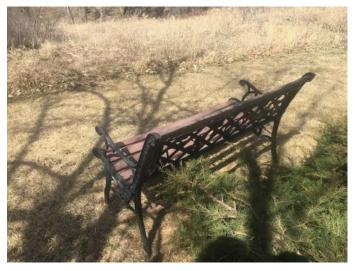
# Comp #: 1307 Benches - Replace

- We were able to locate only one bench during the site observation.

- Due to the small quantity of benches and the relatively low individual replacement cost, we recommend replacing as needed with operating funds.

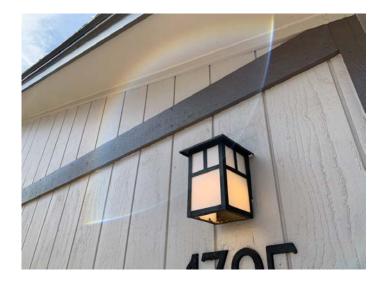
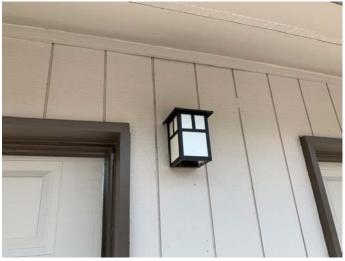
# Comp #: 1602 Exterior Wall Mount - Replace

- It was reported during the revision period the association is responsible for the lights on the garages.
- While replacement can occur on an as needed basis, it is our opinion and recommendation to replace all lights at the same time every 15 20 years to maintain a consistent appearance throughout the property.
- In addition, by replacing multiple fixtures, the association will be able to obtain a quantity discount for the fixtures.

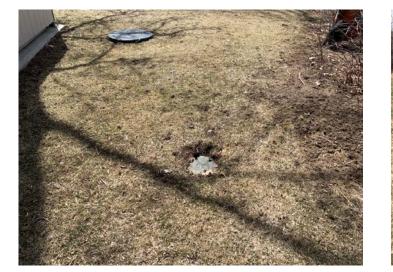
# Comp #: 1701 Irrigation System - Major Repairs

- This line item is for repairs and replacement that lies outside the scope of routine maintenance: bulk sprinkler head replacement, bulk valve replacement, rerouting lateral lines, rewiring, etc.

- In order to ensure the funds are available for major repairs, we recommend reserving funds for these projects every 4 - 5 years.

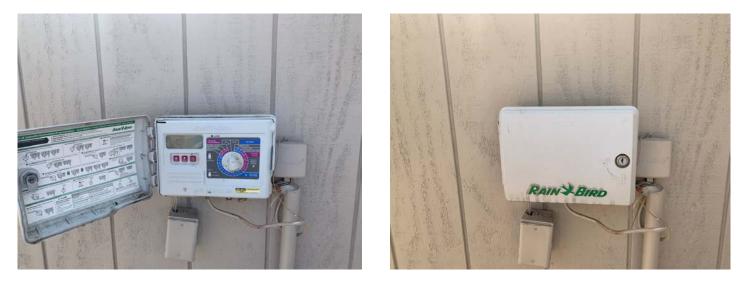
# Comp #: 1703 Irrigation Controllers - Replace

- The overall life expectancy of irrigation controllers typically ranges between 10 - 12 years if properly maintained and under normal conditions.

- This controller was replaced after the site observation was completed and was reportedly replaced for \$200 or \$300.
- Due to the low replacement cost, we have removed funding. This should be replaced as needed using operating funds.

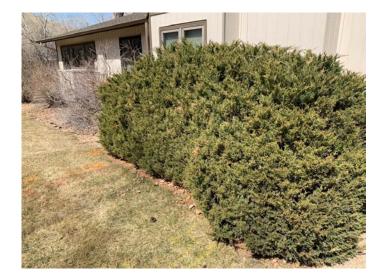
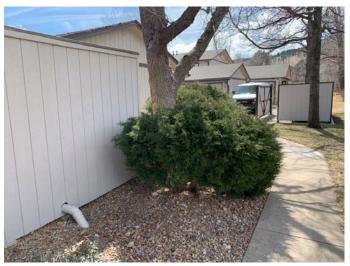
# Comp #: 1801 Groundcover - Replenish

- This line item, similar to irrigation repairs, is for projects that lie outside the scope of routine maintenance.
- In order to preserve an attractive curb appeal and to maintain the health of the plants and shrubs, we recommend reserving for refurbishment projects every 2 3 years.
- Per the request of the current Board of Directors, we have removed funding for this line item.
- It was reported costs associated with this line item will be handled as needed with operating funds.

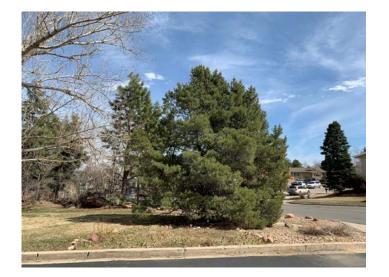
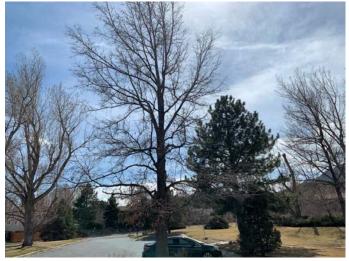
# Comp #: 1804 Tree - Replacement/Major Maintenance

- It is very difficult to predict a replacement cycle for trees as there are several factors such as disease, infestation of insects, heavy snow storms, etc. can all attribute to eventual tree replacement.

Since it is difficult to predict when the replacement will be necessary, Reserve funding is typically not a factor.
 Therefore, unless requested by the association, Reserve funding will not be included as part of the study for this component.
